# Manhole Inspection Summary

Manhole # S67Y\_\_005MH

Insp Date: **5/7/08 9:55 AM**

**Location** Address: **6300 Beckley St.**

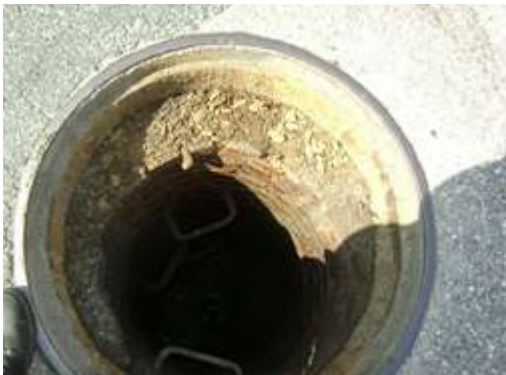
Defect 2

**Frame** Offset: **4** (in.) Condition: ☒ Sound ☐ Cracked ☐ Leaks

Offset frame

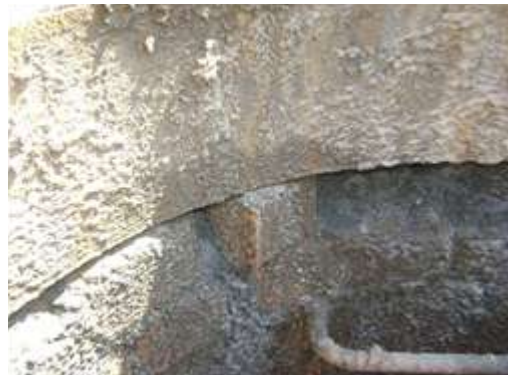
Defect 5

Infiltration: ☐ None ☒ **Joint** ☐ Cracks ☐ Mortar ☐ Roots ☒ **Wall**

Infiltration under frame

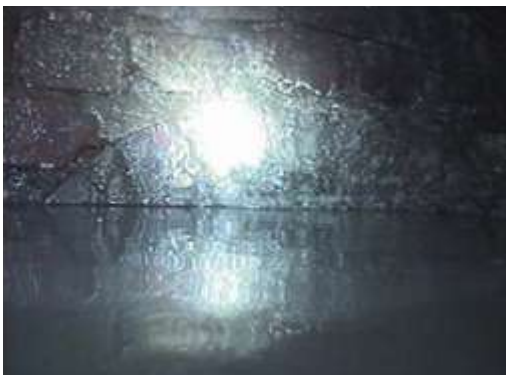
Defect 1

**Surcharge** ☒ **Evidence Of Surcharge** Depth: **3** (ft.) ☐ Active Surcharge Present

SURCHARGE

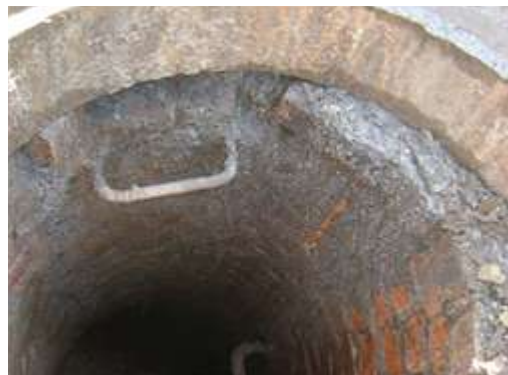
Defect 3

Condition: ☐ Sound ☒ **Cracked** ☐ Root Intrusion ☒ **Loose Brick** ☒ **Deteriorated**

LOOSE BRICK

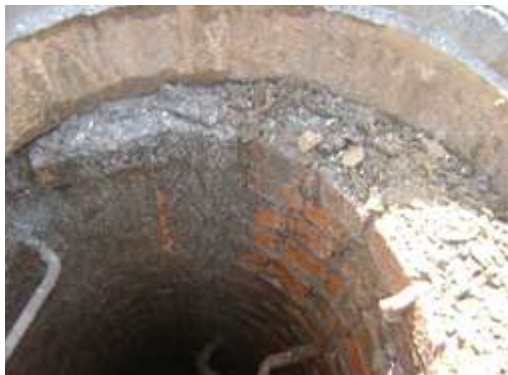
### Defect 4

DETERIORATION

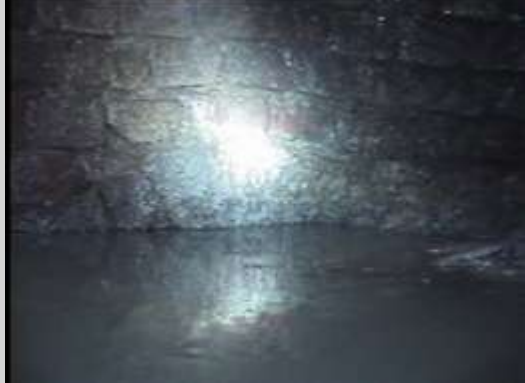
12 O'Clock Outflow

15 in. Circular Gravity Sewer  
Pipe Out @ 12 O'Clock

Pipe Height: **14.4** (in.) Rod and Bar (Angled)  
Pipe Material: **Clay** ☐ Pipe Lined  
Invert Depth: **12.50** (ft.) Flow Characteristics: **Slow**  
Deposits: ☐ None ☐ Mud ☐ Sludge ☒ **Debris** ☐ Grease  
Silt Depth: **3** (in.) Deposits Extent: **Heavy**  
Infiltration: **None** Pipe Seal Cond: **Sound**

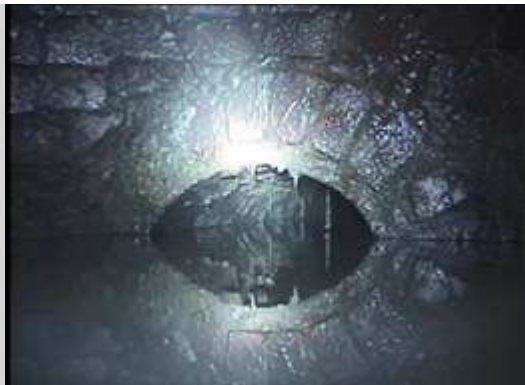
6 O'Clock Inflow

15 in. Circular Gravity Sewer  
Pipe In @ 6 O'Clock

Pipe Height: **15.6** (in.) Rod and Bar (Angled)  
Pipe Material: **Clay** ☐ Pipe Lined  
Invert Depth: **12.42** (ft.) Flow Characteristics: **Slow**  
Deposits: ☐ None ☐ Mud ☐ Sludge ☒ **Debris** ☐ Grease  
Silt Depth: **3** (in.) Deposits Extent: **Heavy**  
Infiltration: **None** Pipe Seal Cond: **Sound**
